**Flood Control Project Maintenance  
Levee Inspections**

## Maintenance Issue Types Only, Levee Inspection Report By Mile - Spring 2019

### Reclamation District No. 0563 Tyler Island

Waterway	Bank	Unit Miles	Inspection Start/End	Inspector
Unit No. 01 Georgiana Slough (Tyler Island)	Left	12.11	04/05/2019 04/05/2019	David Julian

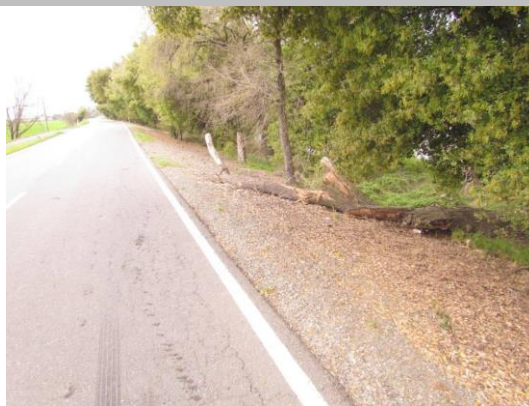
Photo 1 of 2 : SP\_2019\_RD0563\_210\_32\_20190311\_00015.jpg

Looking downstream at tree branch on waterward slope. (Spring 2017)

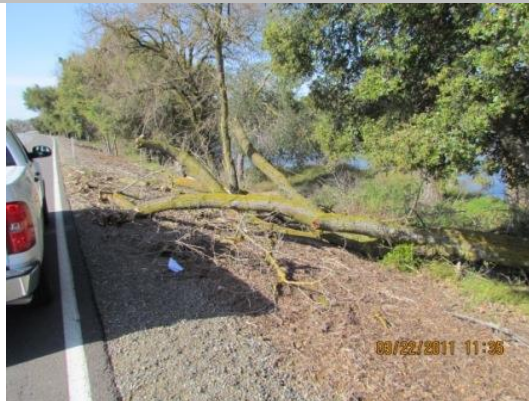
Photo 2 of 2 : SP\_2019\_RD0563\_210\_32\_20190311\_00016.jpg

Looking downstream at fallen tree limb on waterside slope. (Spring 2016)

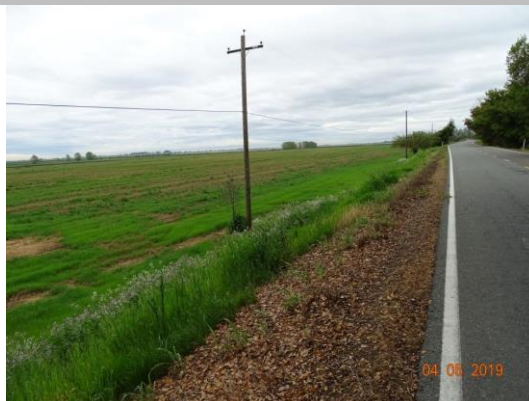
Photo 1 of 1 : SP\_2019\_RD0563\_210\_61\_20190405\_00228.jpg

View looking downstream at annual vegetation on the landside slope (Spring 2019).

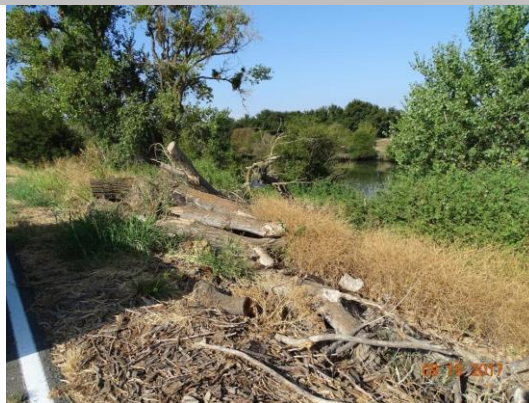
Photo 1 of 1 : SP\_2019\_RD0563\_210\_114\_20190311\_00079.jpg

Looking southwest at the waterside slope.

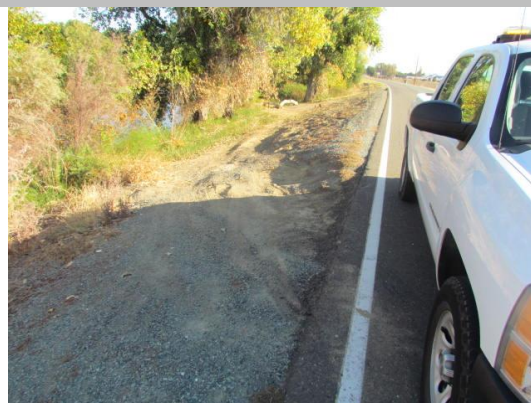
Photo 1 of 1 : SP\_2019\_RD0563\_210\_34\_20190311\_00017.jpg

LM Start	0.53	Rating **	M	Issue No.	34
LM End	0.53	Issue Type +	Ma	Location *	WS
Category	Earthen Levee			GPS Latitude/Longitude	
				Start	End
Item	Slope Stability			38.229232 °	38.229232 °
				-121.523538 °	-121.523538 °
DWR ID	DWR_RD0563_01_f_2018_34				
Comment Code					
S3 : Repair the levee slope damaged by vehicle traffic and prevent access where possible.					
Inspector Comment					
Slope damage is due to vehicle traffic.

Looking northwest at slope damage caused by vehicle traffic.

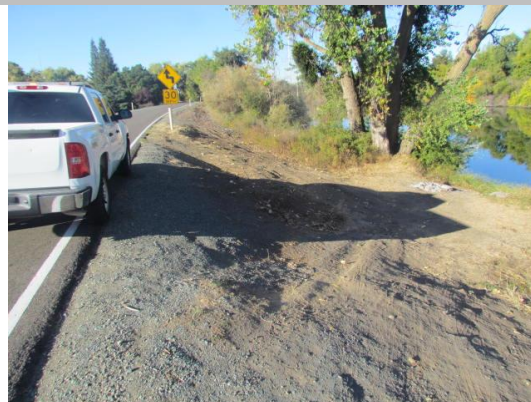
Photo 1 of 2 : SP\_2019\_RD0563\_210\_143\_20190311\_00104.jpg

LM Start	0.56	Rating **	M	Issue No.	143
LM End	0.56	Issue Type +	Ma	Location *	WS
Category	Earthen Levee			GPS Latitude/Longitude	
				Start	End
Item	Slope Stability			38.228930 °	38.228930 °
				-121.523935 °	-121.523935 °
DWR ID	DWR_RD0563_01_f_2014_143				
Comment Code					
S3 : Repair the levee slope damaged by vehicle traffic and prevent access where possible.					
Inspector Comment					
Slope damage is due to vehicle traffic.

Looking southeast at slope damage on waterward slope.

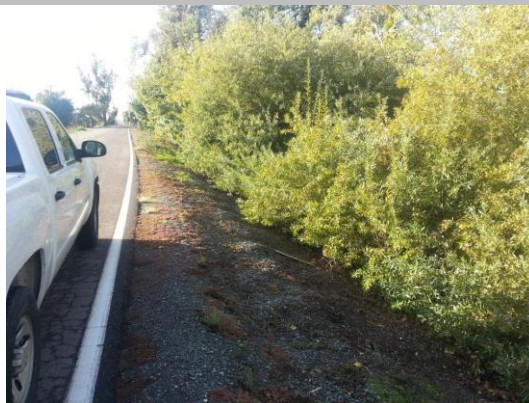
Photo 1 of 2 : SP\_2019\_RD0563\_210\_3\_20190311\_00001.jpg

Looking east at untrimmed trees on waterward slope. (Fall 2016)

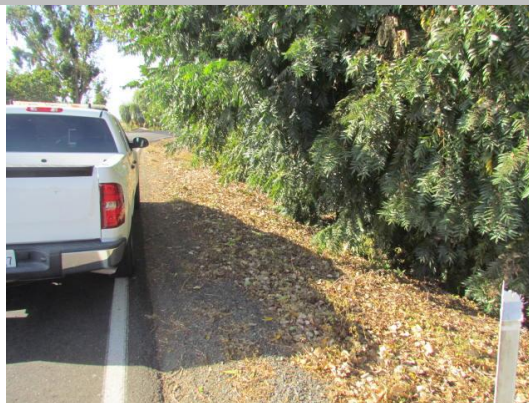
Photo 2 of 2 : SP\_2019\_RD0563\_210\_3\_20190311\_00002.jpg

Looking east at untrimmed trees on waterward slope and toe. (Spring 2016)

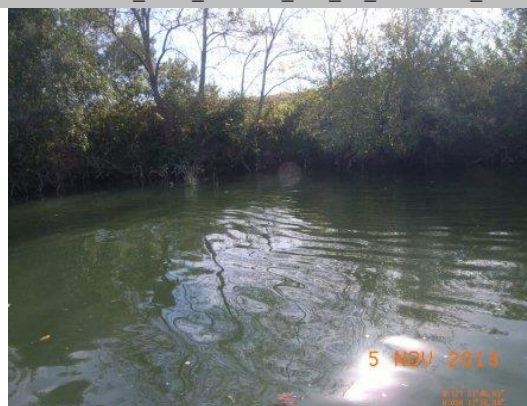
Photo 1 of 1 : SP\_2019\_RD0563\_210\_70\_20190311\_00029.jpg

LM Start	0.92	Rating **	M	Issue No.	70	
LM End	1.11	Issue Type +	Ma	Location *	WS	
Category	Supplemental			GPS Latitude/Longitude		
				Start	End	
Item	2017 USACE Erosion Survey, DRAFT			38.225660 °	38.227157 °	
				-121.527556 °	-121.530432 °	
DWR ID	DWR_RD0563_01_f_2018_70					
Comment Code						
Inspector Comment						
2017 Site ID: GEO 11.0 L						
Status: Eroding						
2017 Field Notes: Increased toe erosion, slumping, boat wake erosion, and revetment failure near downstream end. Site extended upstream.						
Site History: 2011 - Short sections of eroding bank at the waterline and holes in toe of levee. 2012 - Site extended upstream. 2013 - Erosion pockets filled with an insufficient amounts of revetment. 2016 - Fresh erosion observed.

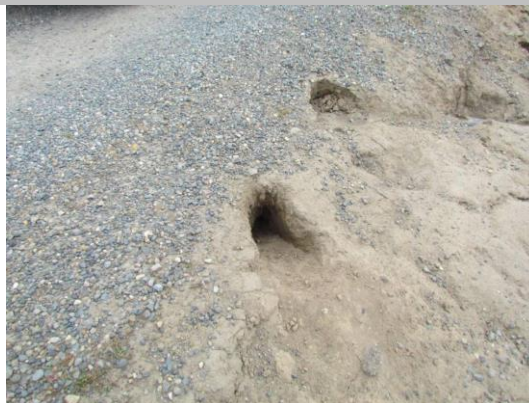
Photo 1 of 2 : SP\_2019\_RD0563\_210\_121\_20190311\_00084.jpg

Looking at typical rodent hole at this location.

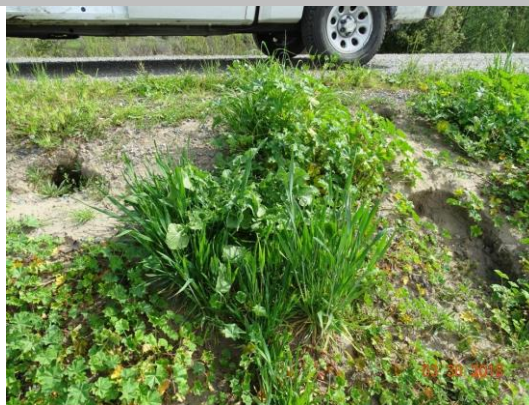
Photo 2 of 2 : SP\_2019\_RD0563\_210\_121\_20190311\_00085.jpg

3/30/2018: Rodent burrows on landside.

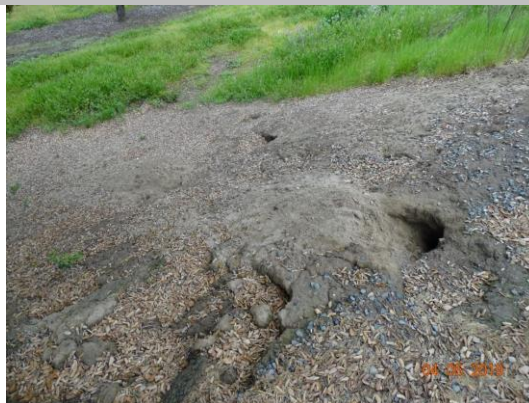
Photo 1 of 1 : SP\_2019\_RD0563\_210\_147\_20190405\_00229.jpg

View of squirrel holes with recent rodent activity (Spring 2019).

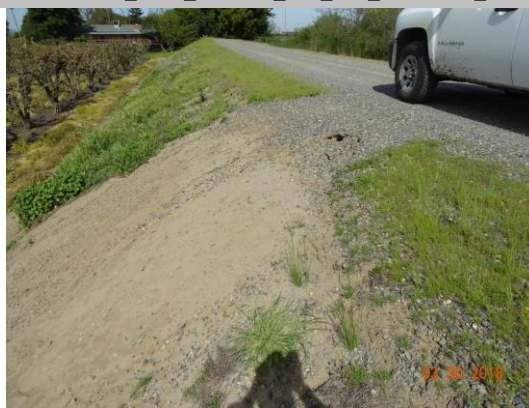
Photo 1 of 1 : SP\_2019\_RD0563\_210\_110\_20190311\_00077.jpg

LM Start	1.03	Rating **	U	Issue No.	110
LM End	1.03	Issue Type +	Ma	Location *	LS
Category	Earthen Levee			GPS Latitude/Longitude	
				Start	End
Item	Animal Control			38.226422 °	38.226422 °
				-121.529410 °	-121.529410 °
DWR ID	DWR_RD0563_01_s_2018_110				
Comment Code					
A3 : No rodents visible, but rodent burrows visible; need to backfill and compact or grout burrows.					
Inspector Comment					
A very large rodent burrow has caused the landside shoulder to collapse. The shoulder should be restored.

3/30/2018: Very large rodent burrow causing caving at landside shoulder.

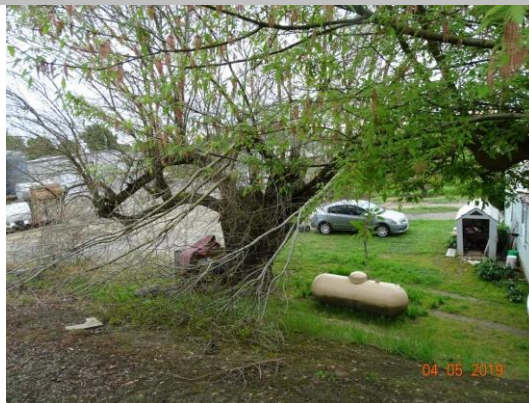
Photo 1 of 1 : SP\_2019\_RD0563\_210\_79\_20190405\_00230.jpg

View looking downslope of recently downed branches on landside slope (Spring 2019).

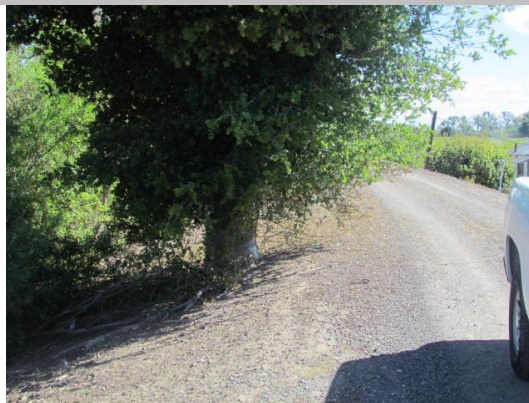
Photo 1 of 1 : SP\_2019\_RD0563\_210\_759\_20190311\_00119.jpg

Looking northwest at untrimmed trees on waterward slope and toe.

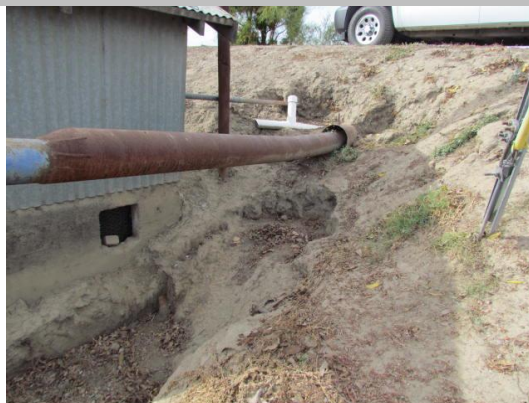
Photo 1 of 2 : SP\_2019\_RD0563\_210\_71\_20190311\_00030.jpg

Looking west at erosion at landside toe and slope next to pump house.

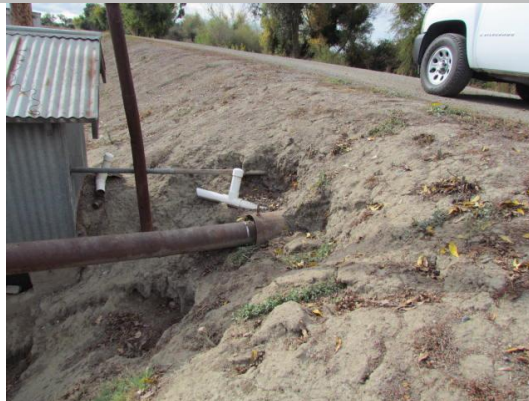
Photo 2 of 2 : SP\_2019\_RD0563\_210\_71\_20190311\_00031.jpg

Looking southwest at erosion around irrigation pipe on landside slope and toe.

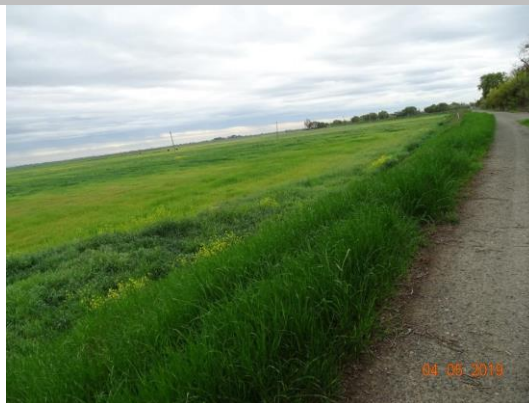
Photo 1 of 1 : SP\_2019\_RD0563\_210\_152\_20190405\_00231.jpg

View looking downstream at annual vegetation on the landside slope (Spring 2019).

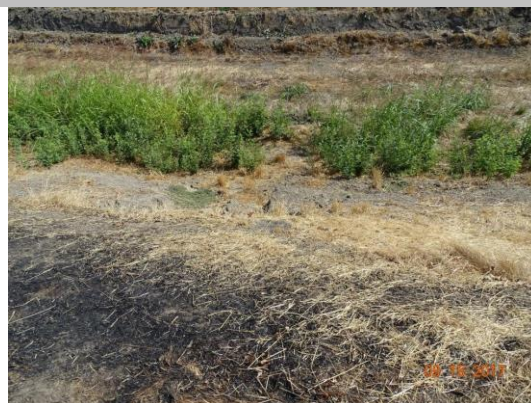
Photo 1 of 1 : SP\_2019\_RD0563\_210\_116\_20190311\_00080.jpg

LM Start	2.25	Rating **	A/W	Issue No.	116
LM End	2.25	Issue Type +	Ma	Location *	LS
Category	Earthen Levee			GPS Latitude/Longitude	
				Start	End
Item	Erosion / Bank Caving			38.217588 °	38.217588 °
				-121.542520 °	-121.542520 °
DWR ID	DWR_RD0563_01_s_2017_116				
Comment Code					
E2 : Schedule repair of erosion site prior to the next inspection.					
Inspector Comment					
LMA found the erosion while on patrol during the February Storm 2017.

Looking east at the landside toe erosion.

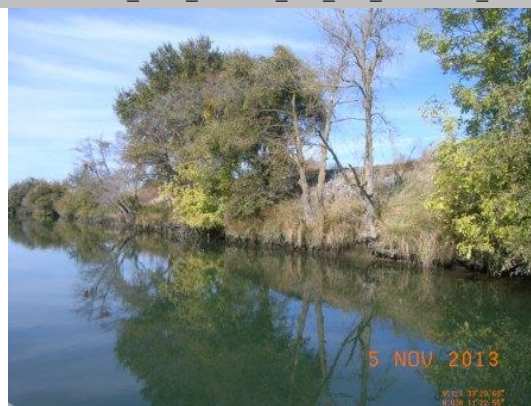
Photo 1 of 1 : SP\_2019\_RD0563\_210\_107\_20190311\_00076.jpg

Comment Code					
Inspector Comment					
2017 Site ID: GEO 9.3 L					
Status: Critical					
2017 Field Notes: Upgraded to critical. Pockets of erosion - subvertical. Areas of failed revetment, old rock is unraveling, and eminent tree popout outs expected.					
Site History: 1997 - Loss of rock at toe; pockets of upper berm erosion; very narrow berm width; toe rock problem; erosion pockets in rock. 2002 - New brush boxes at toe of the worst spots. 2005 - Upstream 200 ft removed because of the wide berm. 2006 - Some rock repair pockets behind the brush boxes at the upstream end. 2010 - Some new erosion. 2013 - New rock placed on the levee slope. 2016 - Fresh erosion along the toe.

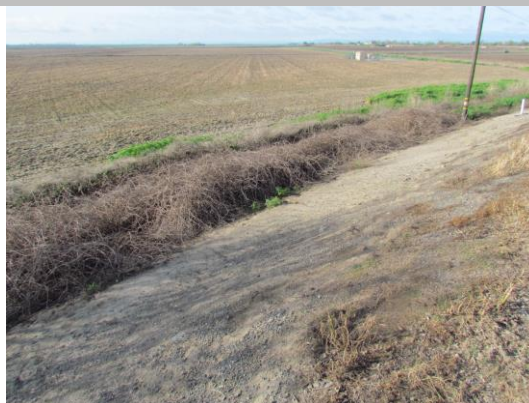
Photo 1 of 2 : SP\_2019\_RD0563\_210\_67\_20190311\_00025.jpg

Looking east at dead berryvines at landward toe. (Spring 2017)

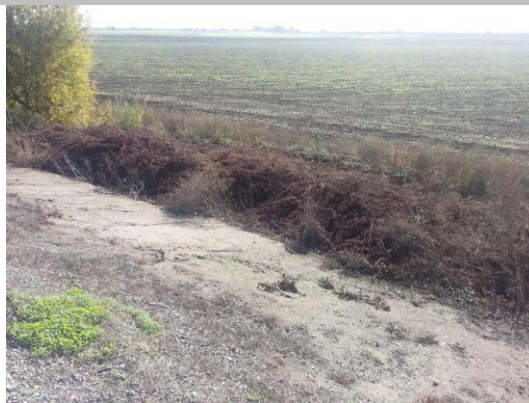
Photo 2 of 2 : SP\_2019\_RD0563\_210\_67\_20190311\_00026.jpg

Looking east at dead berryvines at landward toe. (Fall 2016)

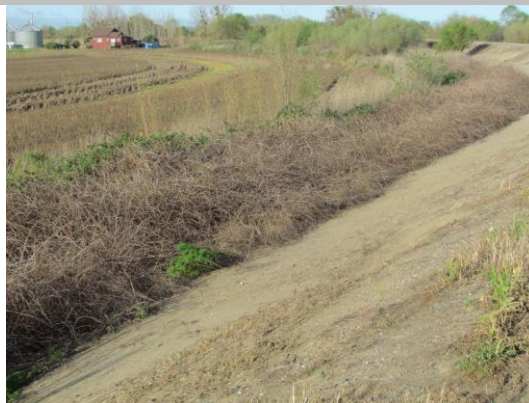
Photo 1 of 5 : SP\_2019\_RD0563\_210\_74\_20190311\_00035.jpg

Looking southeast at dead berryvines along landward toe and berm.  
(Spring 2017)

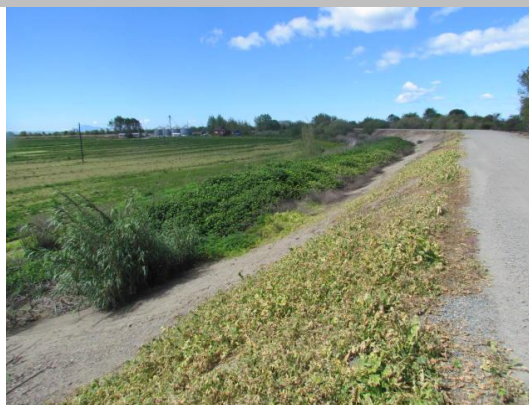
Photo 2 of 5 : SP\_2019\_RD0563\_210\_74\_20190311\_00036.jpg

Looking southeast at berryvines at landward toe., (Spring 2016)

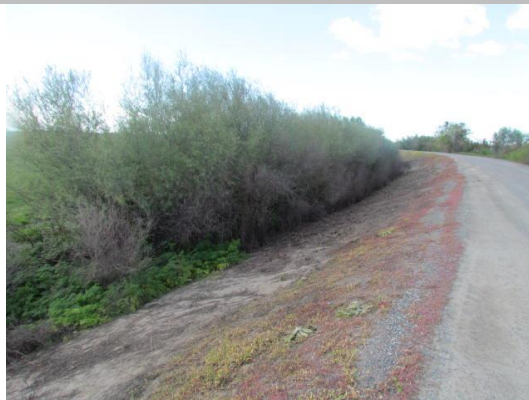
Photo 3 of 5 : SP\_2019\_RD0563\_210\_74\_20190311\_00037.jpg

Looking south at dense vegetation (willows) at landward toe. (Spring 2016)

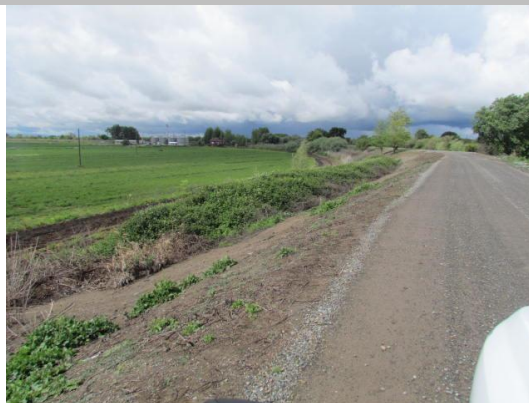
Photo 4 of 5 : SP\_2019\_RD0563\_210\_74\_20190311\_00038.jpg

Looking southeast at dense berryvines at landward toe. (Spring 2015)

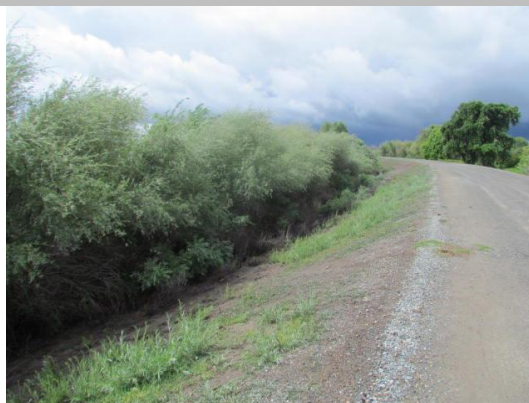
Photo 5 of 5 : SP\_2019\_RD0563\_210\_74\_20190311\_00039.jpg

Looking south at dense vegetation at landward slope and toe. (Spring 2015)

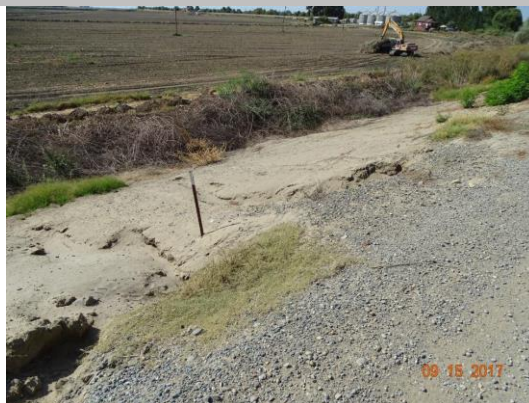
Photo 1 of 5 : SP\_2019\_RD0563\_210\_78\_20190311\_00045.jpg

LM Start	3.06	Rating **	U	Issue No.	78
LM End	3.06	Issue Type +	Ma	Location *	LS
Category	Earthen Levee			GPS Latitude/Longitude	
				Start	End
Item	Slope Stability			38.210240 °	38.210240 °
				-121.537517 °	-121.537517 °
DWR ID	DWR_RD0563_01_s_2012_78				
Comment Code					
S1 : Repair slope instability.					
Inspector Comment					
Slope damage on landside shoulder and slope has been in place for several inspection cycles. Proper drainage should be provided to prevent further erosion, and erosion should be repaired.

Looking southwest at the landside slope.

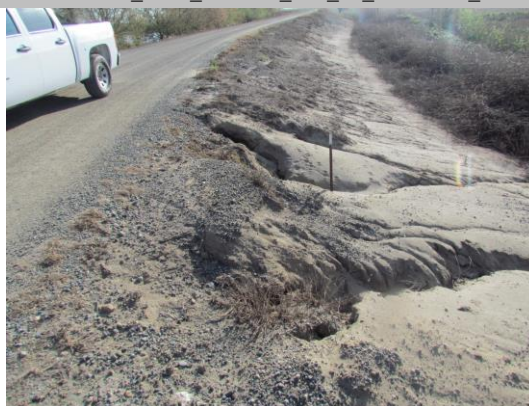
Photo 2 of 5 : SP\_2019\_RD0563\_210\_78\_20190311\_00046.jpg

Looking north at rain runoff erosion on landward slope. (Spring 2017)

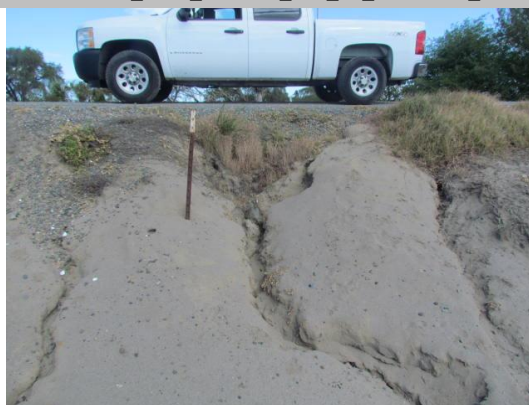
Photo 3 of 5 : SP\_2019\_RD0563\_210\_78\_20190311\_00047.jpg

Looking west at rain runoff erosion on landward slope. (Spring 2016)

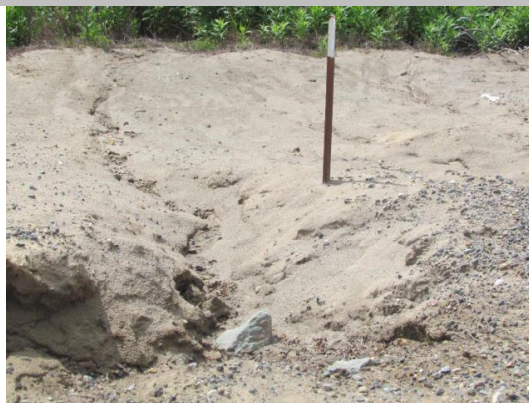
Photo 4 of 5 : SP\_2019\_RD0563\_210\_78\_20190311\_00048.jpg

Looking east at slope erosion. (Updated Spring 2012)

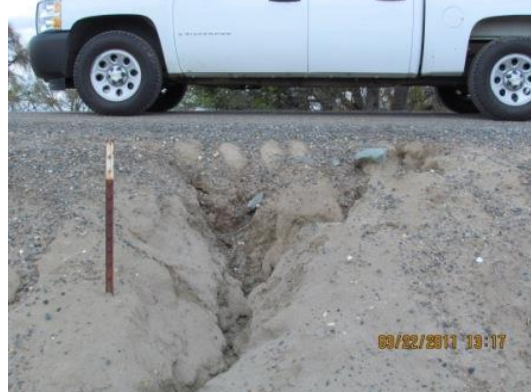
Photo 5 of 5 : SP\_2019\_RD0563\_210\_78\_20190311\_00049.jpg

Looking west at slope erosion cause by runoff on landside slope.

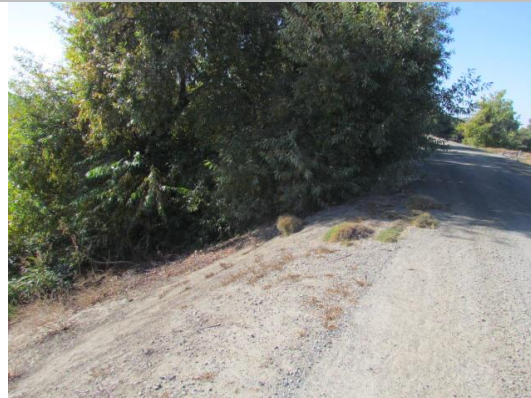
Photo 1 of 2 : SP\_2019\_RD0563\_210\_68\_20190311\_00027.jpg

Looking south at dense trees on landward slope.

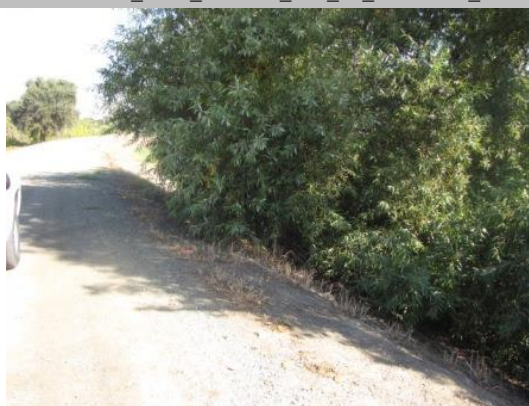
Photo 2 of 2 : SP\_2019\_RD0563\_210\_68\_20190311\_00028.jpg

Looking southeast at dense trees on landside slope and toe.

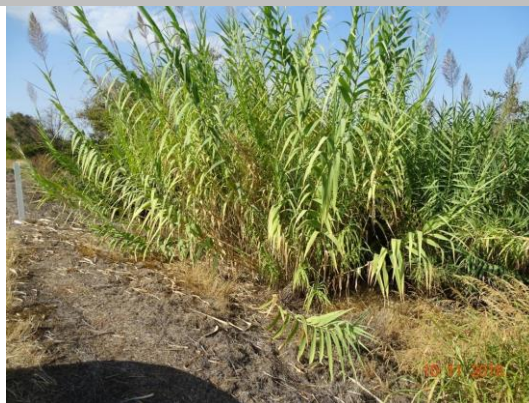
Photo 1 of 1 : SP\_2019\_RD0563\_210\_146\_20190311\_00107.jpg

View of arundo on waterside slope (October 2018).

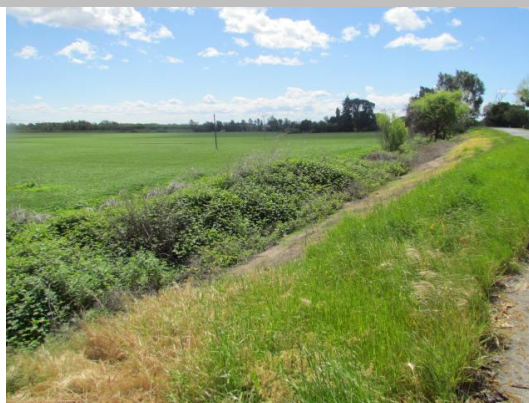
Photo 1 of 1 : SP\_2019\_RD0563\_210\_164\_20190311\_00116.jpg

Looking east at dense vegetation (vines) at landward toe.

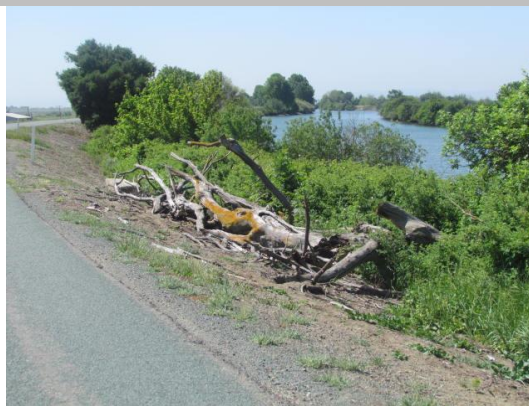
Photo 1 of 1 : SP\_2019\_RD0563\_210\_95\_20190311\_00066.jpg

Looking southwest at tree on waterward slope.

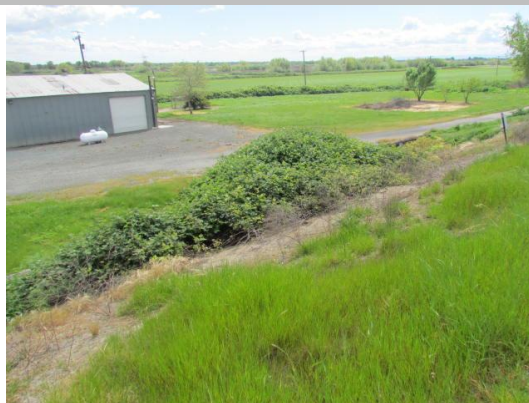
Photo 1 of 1 : SP\_2019\_RD0563\_210\_151\_20190311\_00112.jpg

Looking southeast at dense vegetation at landward toe.

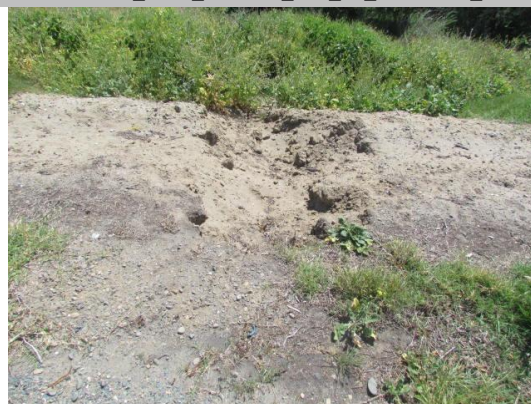
Photo 1 of 1 : SP\_2019\_RD0563\_210\_97\_20190311\_00067.jpg

Looking east at slope erosion on landward shoulder and slope.

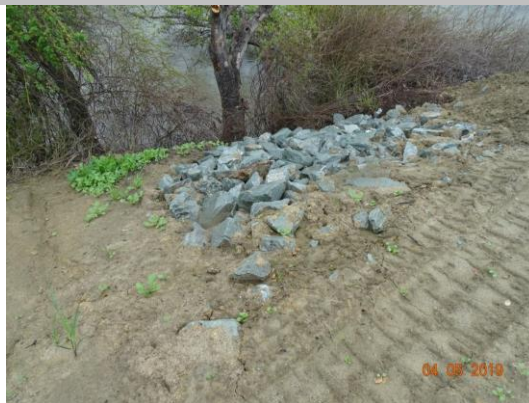
Photo 1 of 1 : SP\_2019\_RD0563\_210\_158\_20190405\_00233.jpg

View of waterside slope repaired by LMA. A beaver hole was discovered on the waterside slope (Spring 2019).

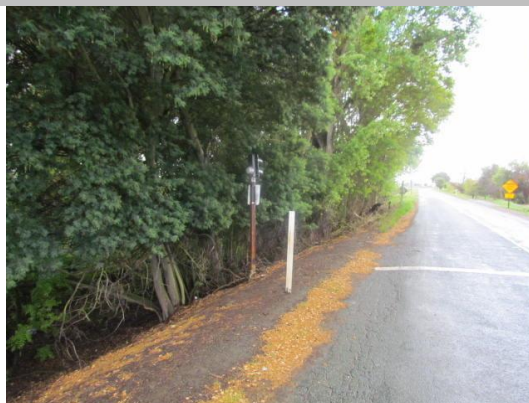
Photo 1 of 1 : SP\_2019\_RD0563\_210\_29\_20190311\_00013.jpg

Looking southeast at dense trees on landward slope and toe.

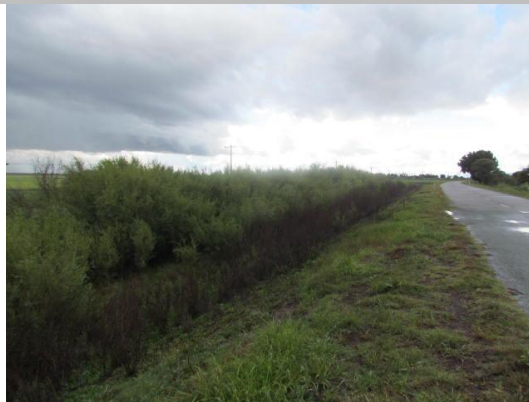
Photo 1 of 3 : SP\_2019\_RD0563\_210\_90\_20190311\_00059.jpg

Looking southeast at dense vegetation at landward toe. (Spring 2015)

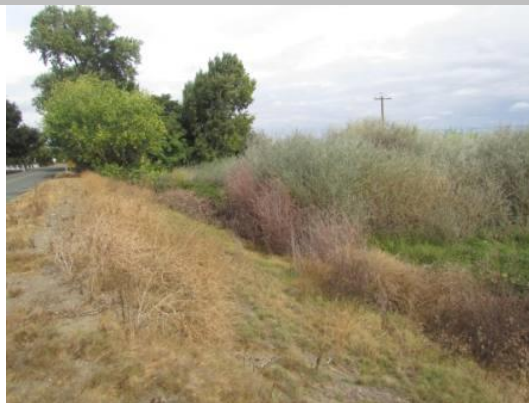
Photo 2 of 3 : SP\_2019\_RD0563\_210\_90\_20190311\_00060.jpg

Looking northeast at dense vegetation on landside toe.

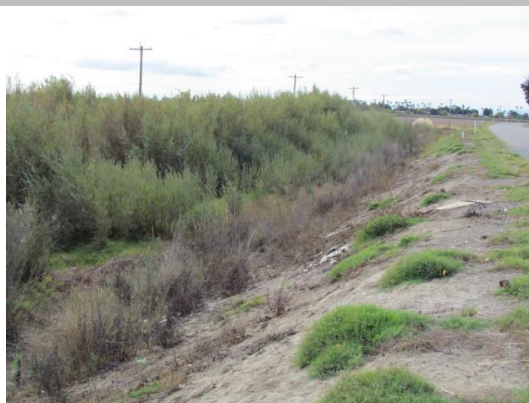
Photo 3 of 3 : SP\_2019\_RD0563\_210\_90\_20190311\_00061.jpg

Looking south at dense vegetation on landside toe. (2012 Fall Inspection)

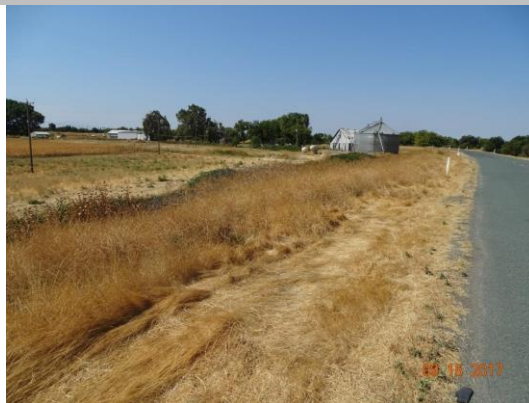
Photo 1 of 1 : SP\_2019\_RD0563\_210\_767\_20190311\_00120.jpg

Looking south at the landside slope.

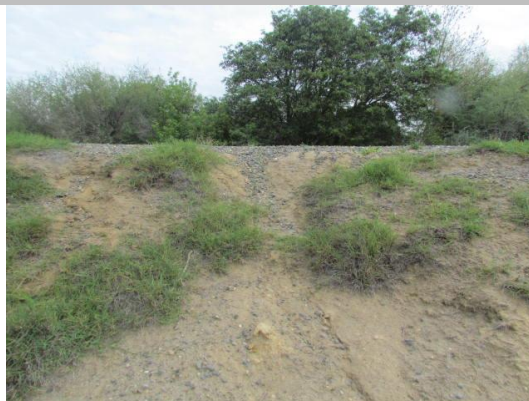
Photo 1 of 2 : SP\_2019\_RD0563\_210\_99\_20190311\_00069.jpg

Looking west at minor erosion on landward shoulder and slope.

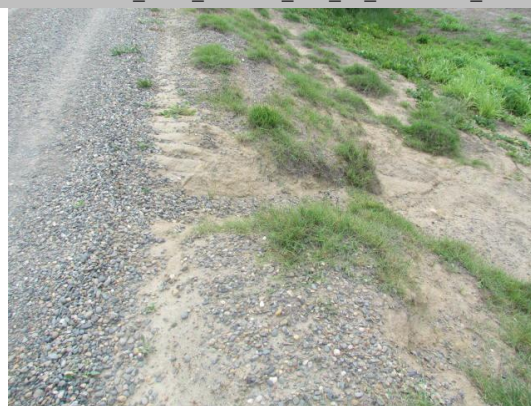
Photo 2 of 2 : SP\_2019\_RD0563\_210\_99\_20190311\_00070.jpg

Looking north at minor erosion on landward shoulder and slope.

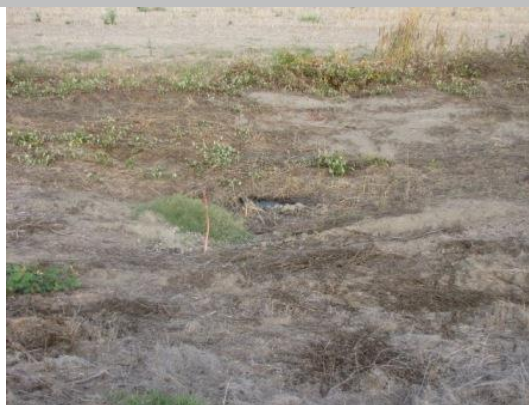
Photo 2 of 4 : SP\_2019\_RD0563\_210\_76\_20190311\_00042.jpg

Looking east at water ponding at landside toe just above 10" irrigation pipe.

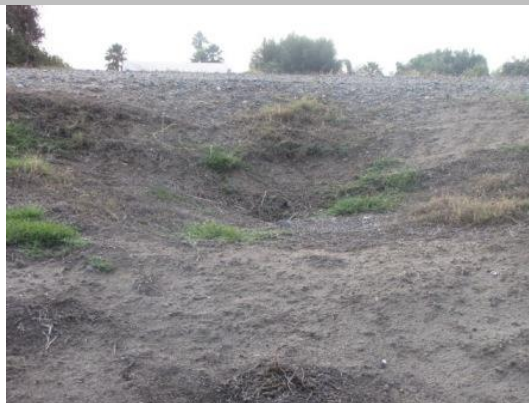
Photo 3 of 4 : SP\_2019\_RD0563\_210\_76\_20190311\_00043.jpg

Looking west at depression on landside shoulder and slope from landside toe.

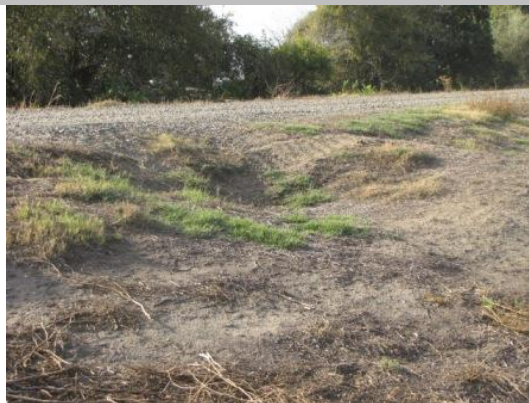
Photo 4 of 4 : SP\_2019\_RD0563\_210\_76\_20190311\_00044.jpg

Looking west at depression on landside shoulder and slope.

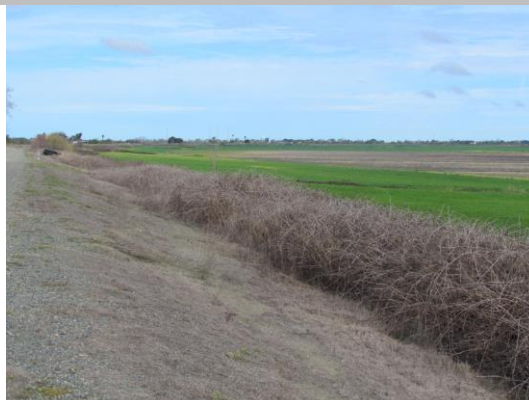
Photo 2 of 3 : SP\_2019\_RD0563\_210\_770\_20190311\_00125.jpg

Looking northeast at dead vines at landward toe. (Spring 2017)

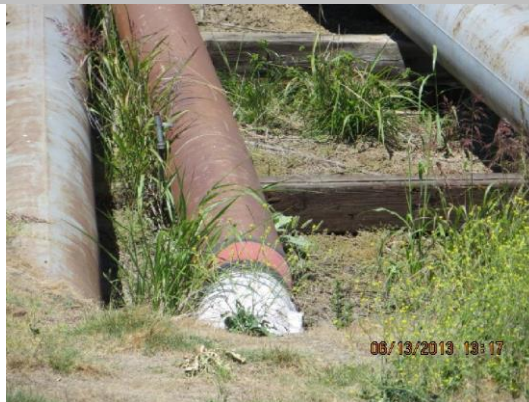
Photo 2 of 3 : UCIP\_SP\_2019\_52771\_24730.jpg

20-inch pipe on LS toe.

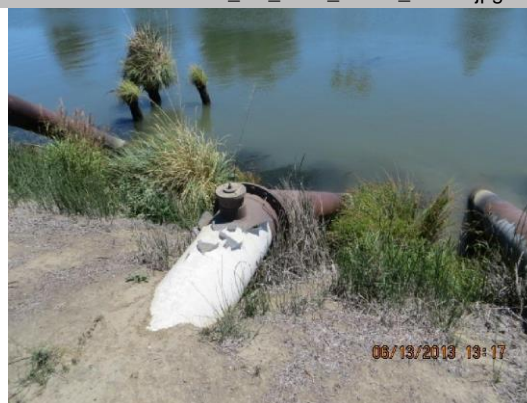
Photo 3 of 3 : UCIP\_SP\_2019\_52771\_24729.jpg

Pipe and siphon breaker on WS shoulder.

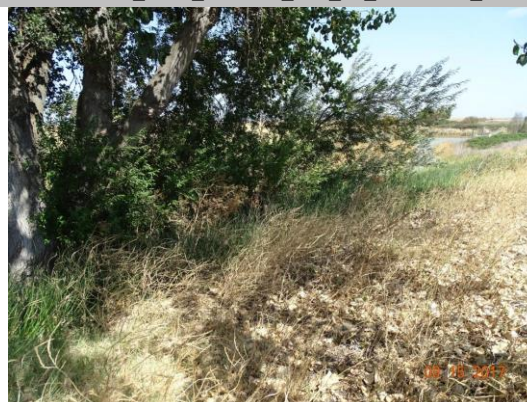
Photo 1 of 2 : SP\_2019\_RD0563\_210\_47\_20190311\_00018.jpg

Looking northeast at the landside slope.

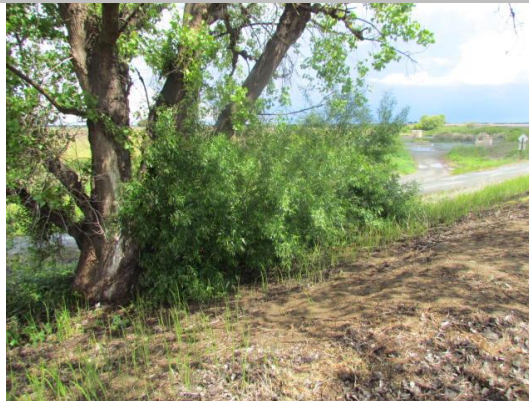
Photo 2 of 2 : SP\_2019\_RD0563\_210\_47\_20190311\_00019.jpg

Looking northeast at untrimmed tree at landward slope. (Spring 2015)
